The effects of heat treatment on the mechanical properties of cold-sprayed coatings

Renzhong Huang, Michiyoshi Sone, Wenhua Ma, Hirotaka Fukanuma

Plasma Giken Co. Ltd., Toshima, Tokyo, Japan

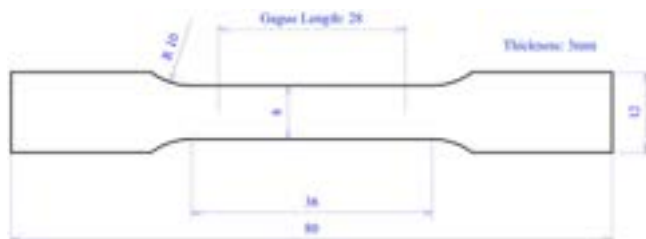
Fig. 3. Dimensions of tensile specimen.

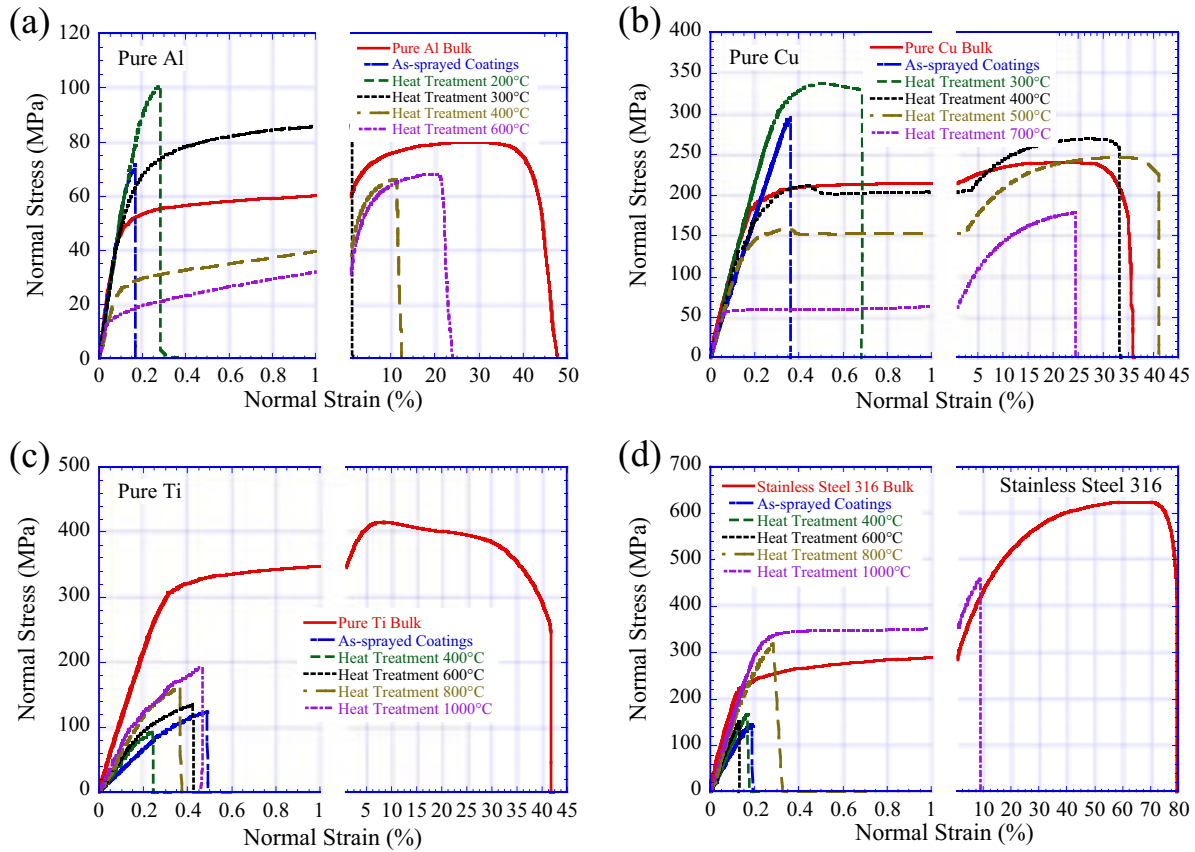
Fig. 4. Tensile properties of cold-sprayed Al (a), Cu (b), Ti (c) and stainless steel 316 (d) coatings.

Fig. 4 shows the tensile properties of cold-sprayed Al, Cu, Ti and stainless steel 316 coatings. It can be seen that all the as-sprayed coatings have poor ductility and their tensile elongations are less than 0.5%. All the mechanical properties (especially elongation) improved with increase in heat treatment temperature.

For the cold-sprayed Al coatings, the as-sprayed coating has a similar tensile strength as the bulk in spite of the poor elongation. After heat treatment at 200 °C, the cold-sprayed Al coating becomes even stronger,

but still with poor ductility. Further improving the heat treatment temperature to 300 °C, the strength of coating decreases compared to that of heat-treated coating at 200 °C. Nevertheless, it is higher than that of the bulk Al. The coating began to have some ductility with an elongation of about 1.3%. With the increase of heat treatment temperature to more than 400 °C, the coating showed decent ductility and gained more than 10% of elongation. However, the tensile strength of coating decreased and became a little lower than the bulk Al after heat-treating at 400 °C. The most excellent properties of Al coating is the one that was heat-treated at 600 °C. The coating possessed elongation of about 25% (half of the bulk material) and ultimate tensile strength of about 70 MPa (close to the bulk material). However, the yield strength of Al coating after treatment temperature at 600 °C decreased to far lower than the bulk material.

For the cold-sprayed Cu coatings, the as-sprayed coating has a higher tensile strength than the bulk Cu. After heat-treating at 300 °C, the cold-sprayed Cu coating becomes stronger, but with poor ductility (less than 1%). Further raising the heat treatment temperature to 400 °C and 500 °C, excellent mechanical properties were obtained. The tensile strength and elongation of coating even exceed that of bulk Cu. When the heat treatment temperature is increased to 700 °C, the tensile strength and elongation of the coating decreased compared with the ones heat-treated at 400 and 500 °C. It seems that excessive heat treatment can generate adverse effect of improving mechanical properties for cold-sprayed Cu coatings.

For cold-sprayed Ti coatings, the tensile strength and elongation are extremely low compared with that of the bulk Ti (even when heat-treated at a higher temperature of 1000 °C). Generally, the tensile strength of Ti coatings is less than 200 MPa and their elongation is less than 0.5%. It seems that the heat treatment did not significantly improve the mechanical properties of cold-sprayed Ti coatings.

For cold-sprayed stainless steel 316 coatings, the tensile strength and elongation have no improvement compared to that of the as-sprayed coating if the heat treatment temperature is less than 600 °C. When the heat treatment temperature is increased to 800 °C, the tensile strength increased to 300 MPa. However, it still revealed poor ductility (less than 0.5%) because the specimen failed before the plastic deformation stage. With the heat treatment temperature of 1000 °C, the strength of stainless steel 316 coating further increased and some ductility starts to appear. However, strength and elongation are still

The heat treatment significantly improved the mechanical properties of cold-sprayed Cu. Nevertheless, almost no effects of heat treatment on the mechanical properties of cold-sprayed Ti can be observed (as shown in Fig. 4). To understand the phenomena, microstructures of Cu and Ti were analyzed.

strength is much less than bulk as shown in Fig. 4(c). For the as-sprayed Al and stainless steel 316 coatings, some defects existed inside as shown in Fig. 12. Consequently, tensile strength of the two materials was decreased by defects. Compared with the bulk materials, the decreased tensile strength of stainless steel coatings is more significant than that of the Al coating as shown in Fig. 4(a) and (d). This is due to porosity in the coatings as shown in Fig. 12 that the stainless steel has more porosity (2.14%) than that in the Al coating (0.87%). The more defects that the coatings may have, the earlier they will fail during the tensile test, consequently a lower tensile strength compared to the bulk materials.

to decrease and some elongation appears as shown in Fig. 4(a). This result is corresponded to Johnson's research that recrystallization temperature of Al is about 300 °C [27]. Unlike Cu, the grain in the Al coating did not become significantly fine because the original grain did not deform much during the deposition process (shown in Fig. 8). Even when the recrystallization happened to the Al coating when heat-treated at 300 °C, the work hardening did not completely remove from the coating. Therefore, coating should have a higher tensile strength and lower elongation compared to the bulk material. Like the stainless steel 316, some defects still remained in the Al coatings as shown in Fig. 8. This will decrease the mechanical properties of Al coating. As a result, Al coating heat-treated at 300 °C has a slightly higher tensile strength and much lower elongation than the bulk material (see Fig. 4(a)). For Ti coating, recrystallization temperature is about 700 °C [28] and heat treatment at 800 and 1000 °C should make the coatings change their mechanical properties. However, since only few particles are deforming, it leads to a small change with the grain during the recrystallization stage as shown in Fig. 6. Diffusion increased the connection strength between the close contact particles, but the

improvement effect becomes quite poor owing to the residual defects (example: big pores). This consequently leads to a brittle de-cohesive rupture as shown in Fig. 10(c). With Ti coating heat-treated at 800 and 1000 °C, poor elongation was obtained and the tensile strength improved a little compared to the as-sprayed coating and far lower than the bulk Ti as shown in Fig. 4(c).

Besides mechanical properties of the yield, ultimate strength and elongation, the elastic properties can also be calculated with the stress–strain curve. Table 4 shows the Young's modulus of cold-sprayed coatings derived from Fig. 4. According to Phani and Niyogi's researches, the elastic properties of porous materials are determined by the porosity [29]. The porosity of materials leads to the Young's modulus of porous materials reduced [29,30]. Meanwhile, the cold-sprayed coating always shows lower Young's modulus due to the existence of separated inter-splat boundaries (tiny cracks) [31,32]. For Cu coating, although almost no pores and defects can be observed in the coating (see Fig. 5), its Young's modulus of as-sprayed coating is still about 20% lower than the corresponding bulk material due to the existence of many unbonded inter-splat boundaries as reported in Ref. 31 to 33. After heat treatment at 300 °C, the Young's modulus of coating becomes close to the bulk Cu since the tiny cracks are repaired during heat treatment via diffusion at the inter-splat boundaries. It seems that the tiny cracks in cold-sprayed Cu coatings are almost completely repaired if the heat treatment temperature is higher than 300 °C since the Young's modulus hardly change any more with the higher heat treatment temperatures. For Al coating, the tiny cracks in the coating added its porosity (0.87%) make the Young's modulus of as-sprayed Al coating lower about 25% compared with its bulk material. After heat treatment at 200 and 300 °C, the Young's modulus increases a little owing the disappearance of some tiny cracks. Further improved the heat treatment temperature to 400 and 600 °C, the yield strength decreases significantly and it is difficult to calculate the Young's modulus owing to the short-time elastic stage during the tensile test. For the stainless steel coatings, some pores (2.14%) and separated inter-splat boundaries can be observed (see Fig. 12(b)). Therefore, the as-sprayed coating has a lower

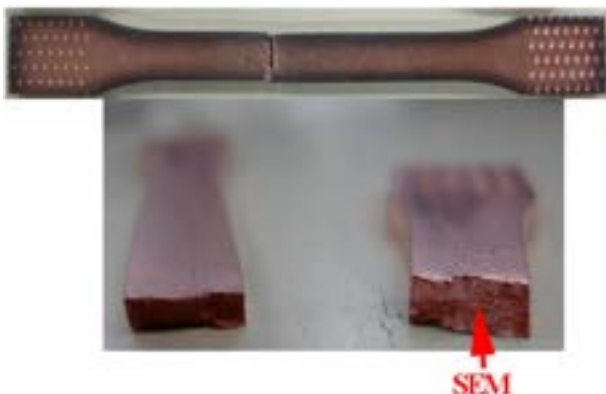
Fig. 7. Observation location of the fractured specimens.

After the tensile test, fracture surface was observed by SEM in order to understand its fracture mechanism. Fig. 7 shows the observation location of the fractured specimens.
